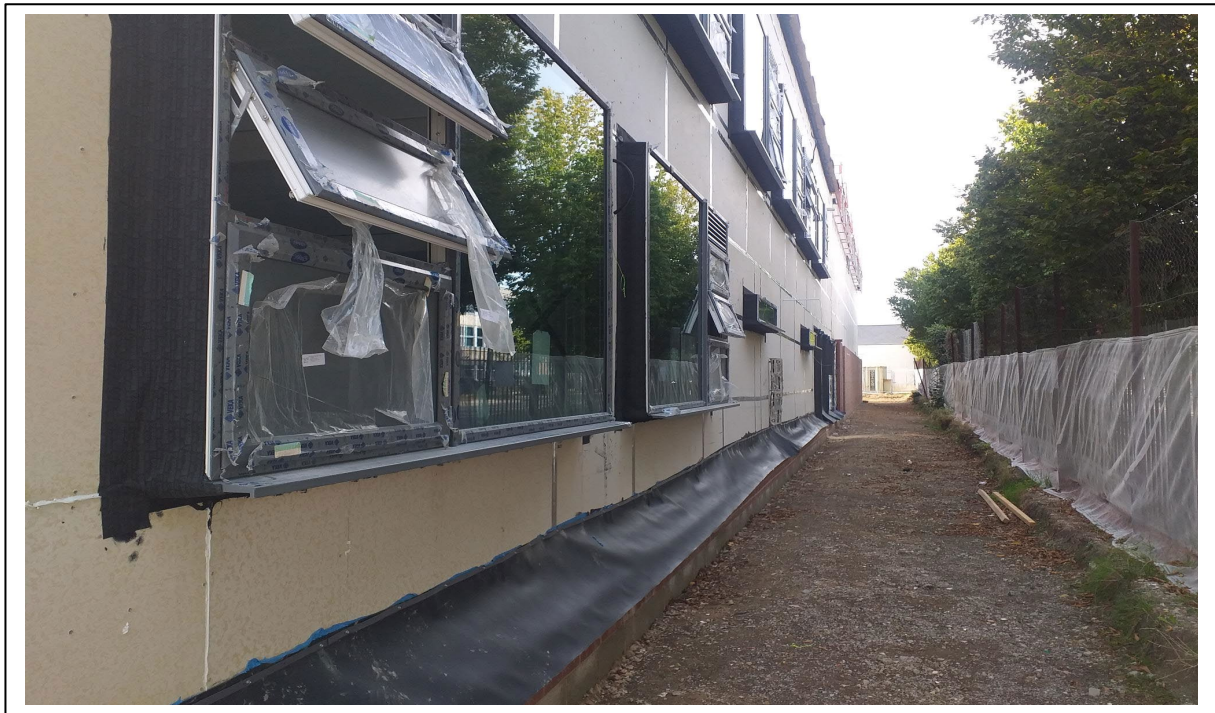
**Location:** South elevation

**Description of Works:** Windows and EPDM fitted, low level cavity tray

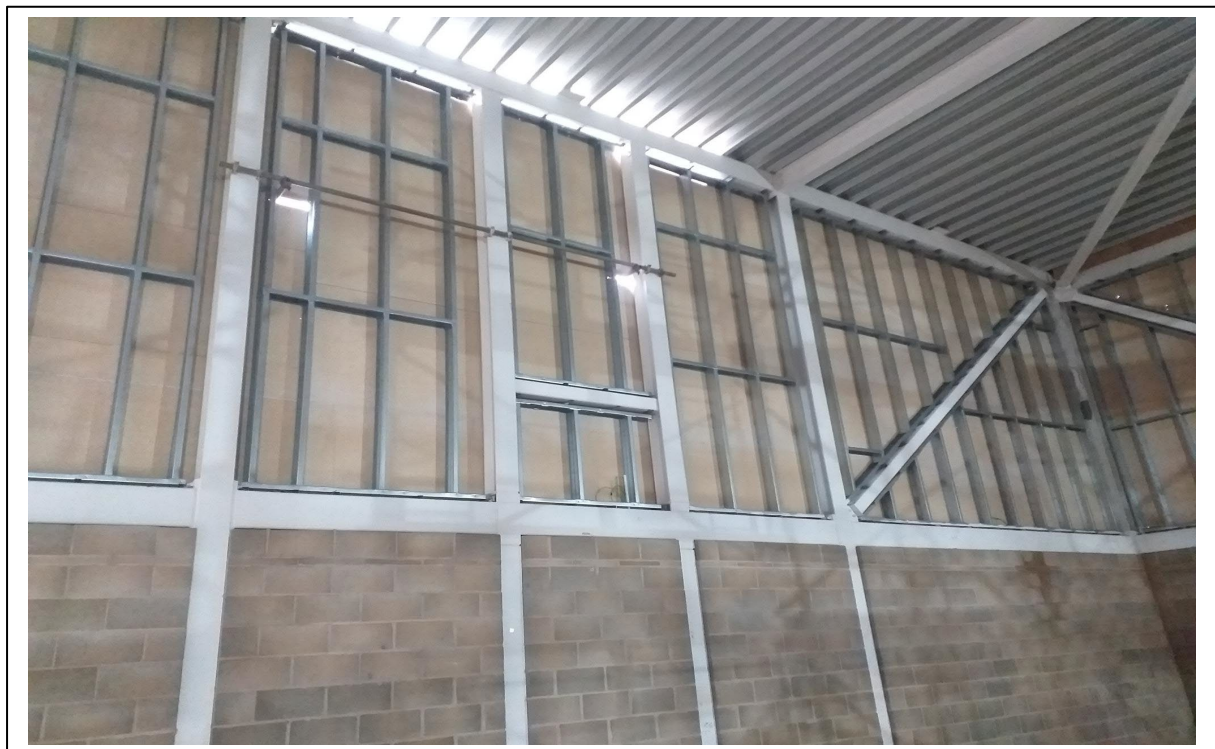
**Location:** Sports hall, West elevation

**Description of Works:** SFS and cement board fitted after Scaffold adapted, low level blockwork  
Metal studwork and plaster board still to do

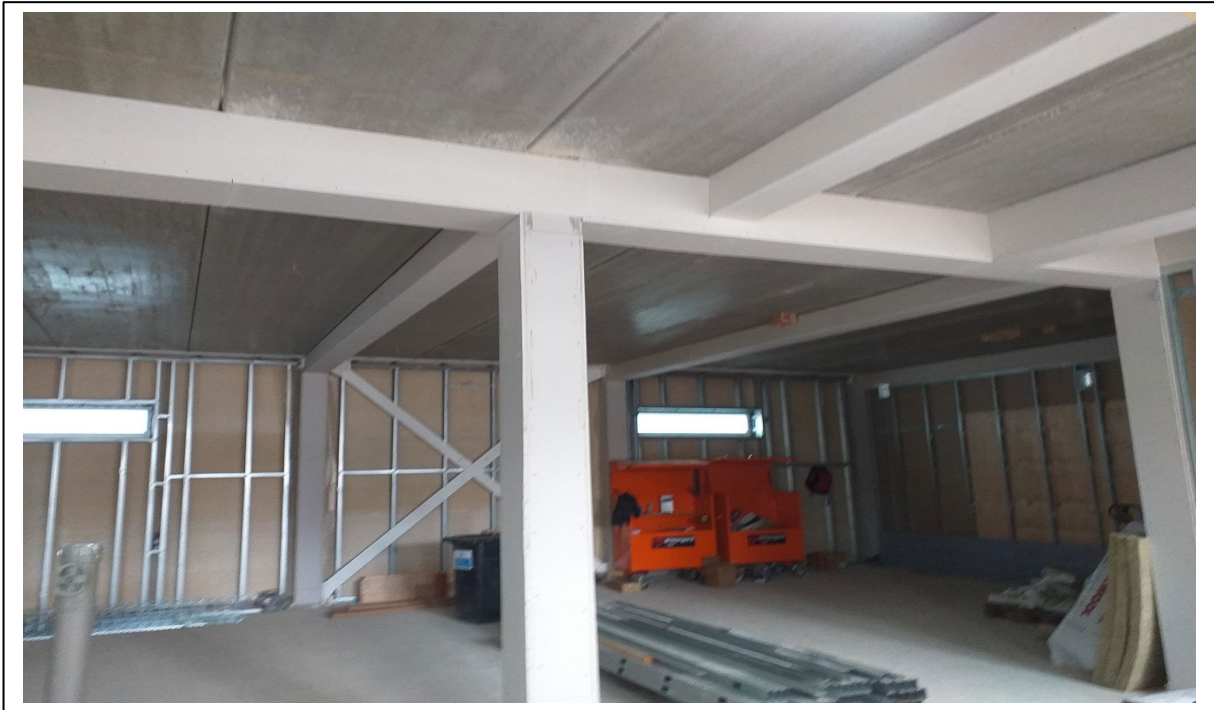
**Location:** Teaching block Ground floor

**Description of Works:** Beam encasements and columns to achieve fire resistance

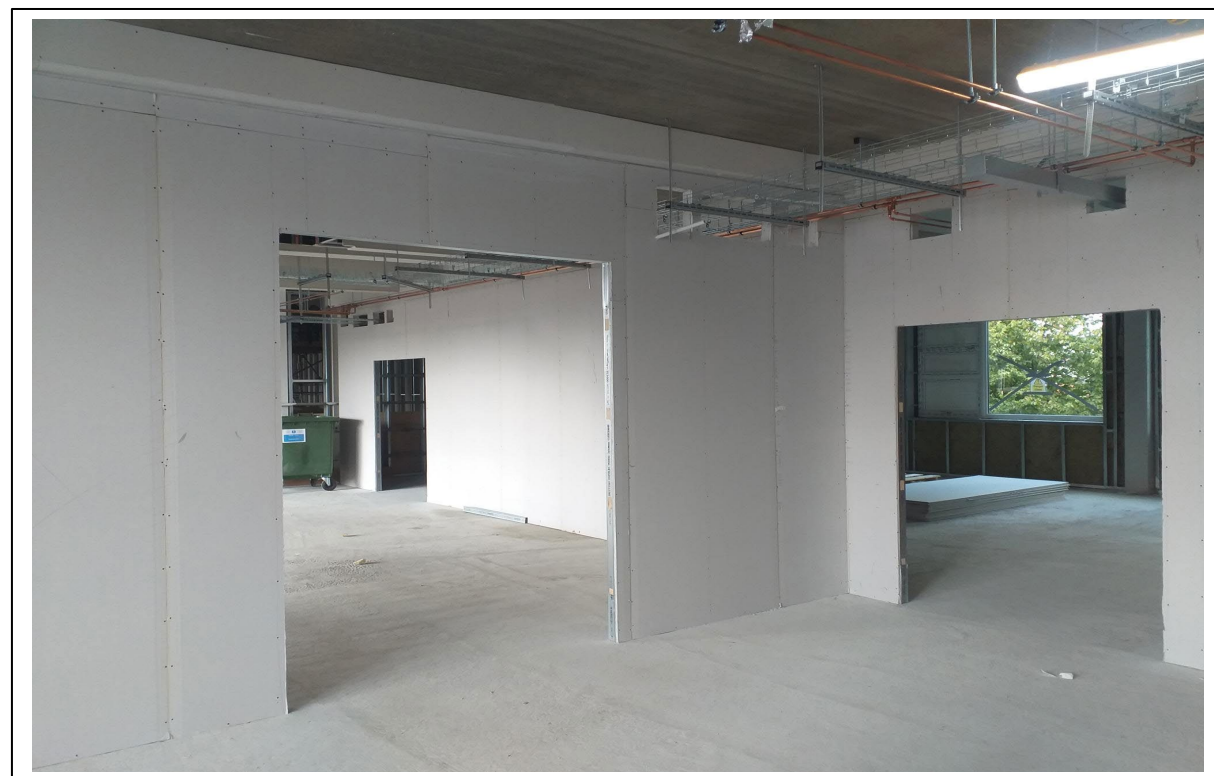
**Location:** Teaching block 1<sup>st</sup> floor

**Description of Works:** Metal stud and boarding partition wall, 1<sup>st</sup> fix mechanical and electrical through letter box

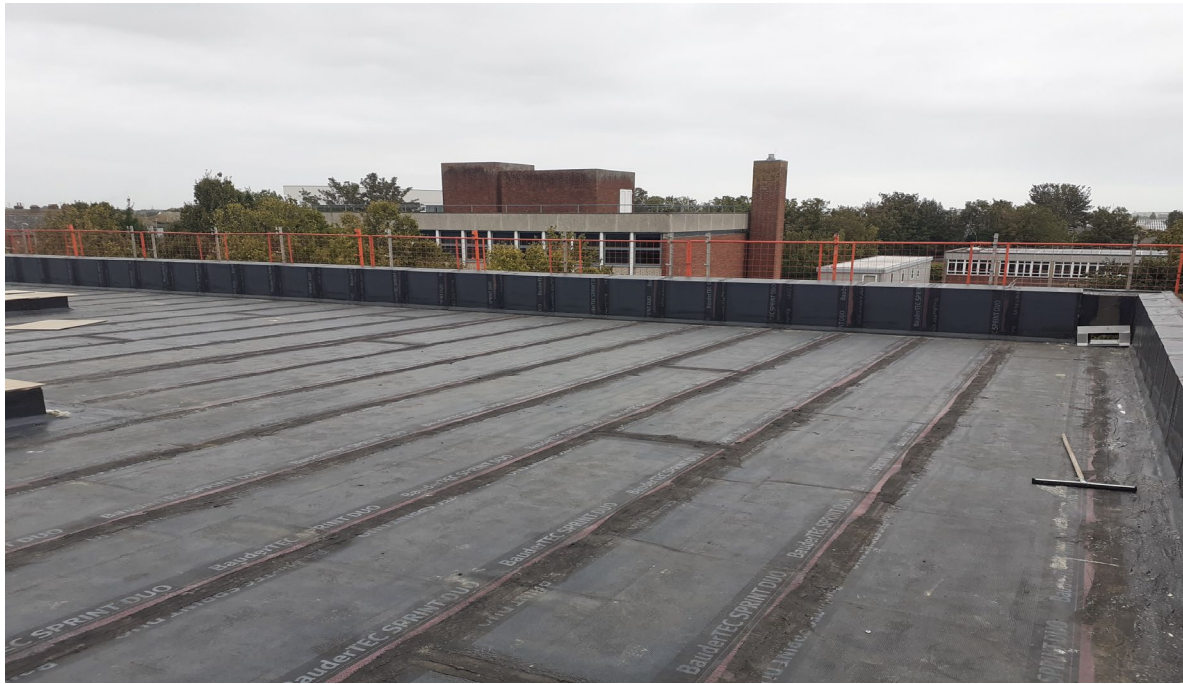
**Location:** Sports hall roof

**Description of Works:** VCL layer, parapet upstands flat lay complete, ready to start mineral felt  
2no outlets to be fitted

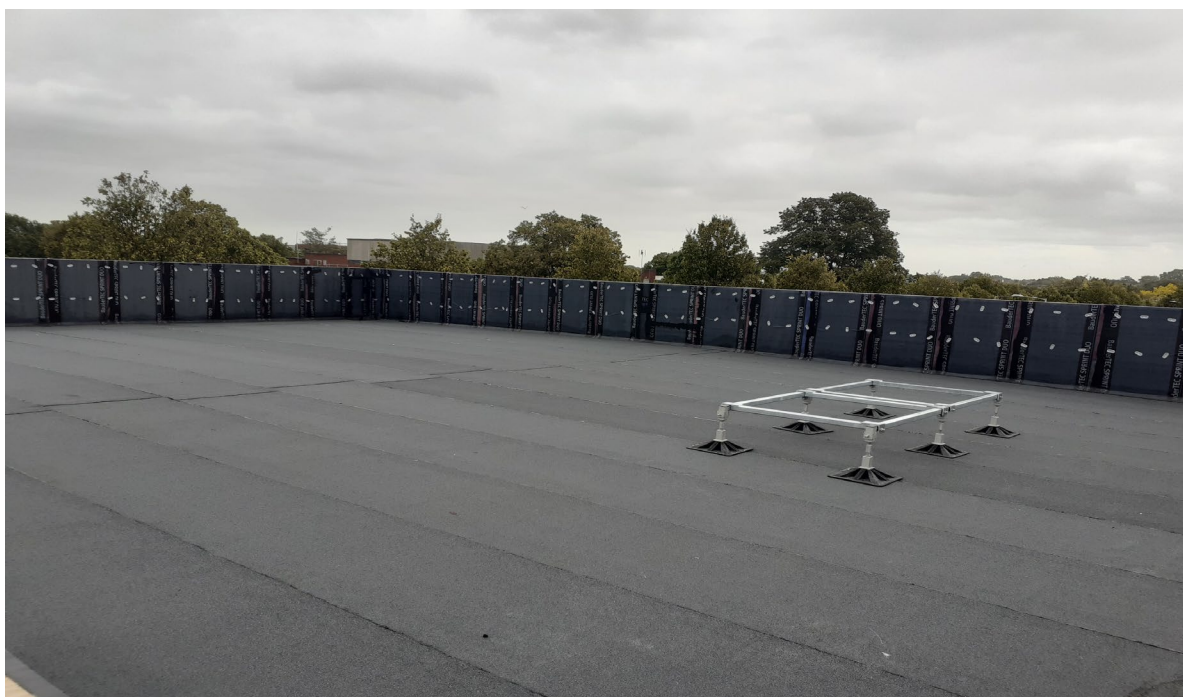
**Location:** Teaching block roof

**Description of Works:** Mineral felt to the flat of the roof 80% complete, parapets are ongoing

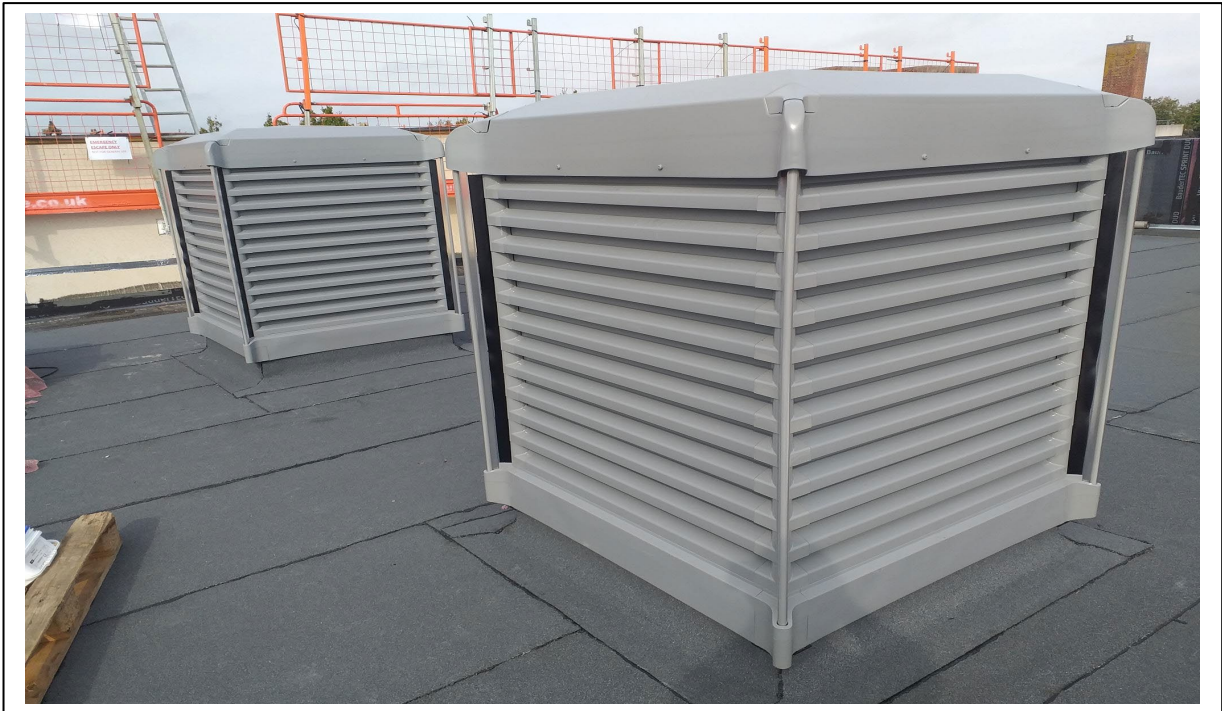
Location: Teaching block

Description of Works: Windcatcher tops fitted onto the teaching block roof for passive ventilation

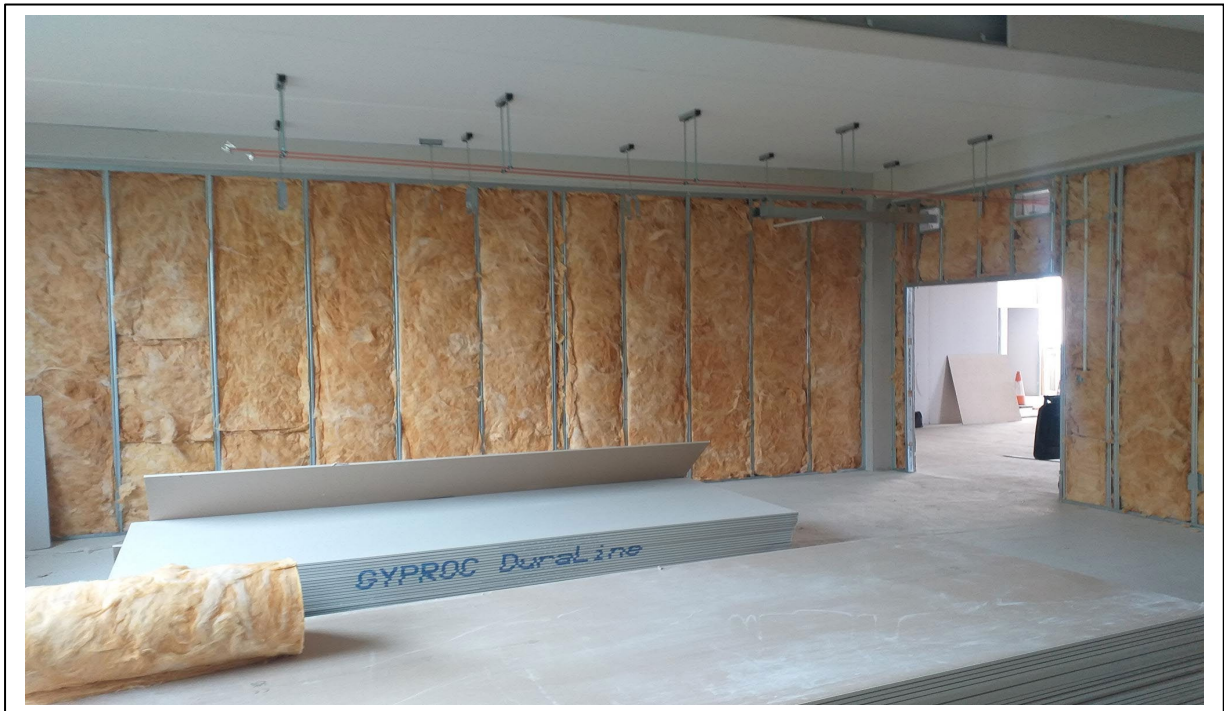
**Location:** Teaching block

**Description of Works:** In wall insulation to keep it cool in summer and warm in winter

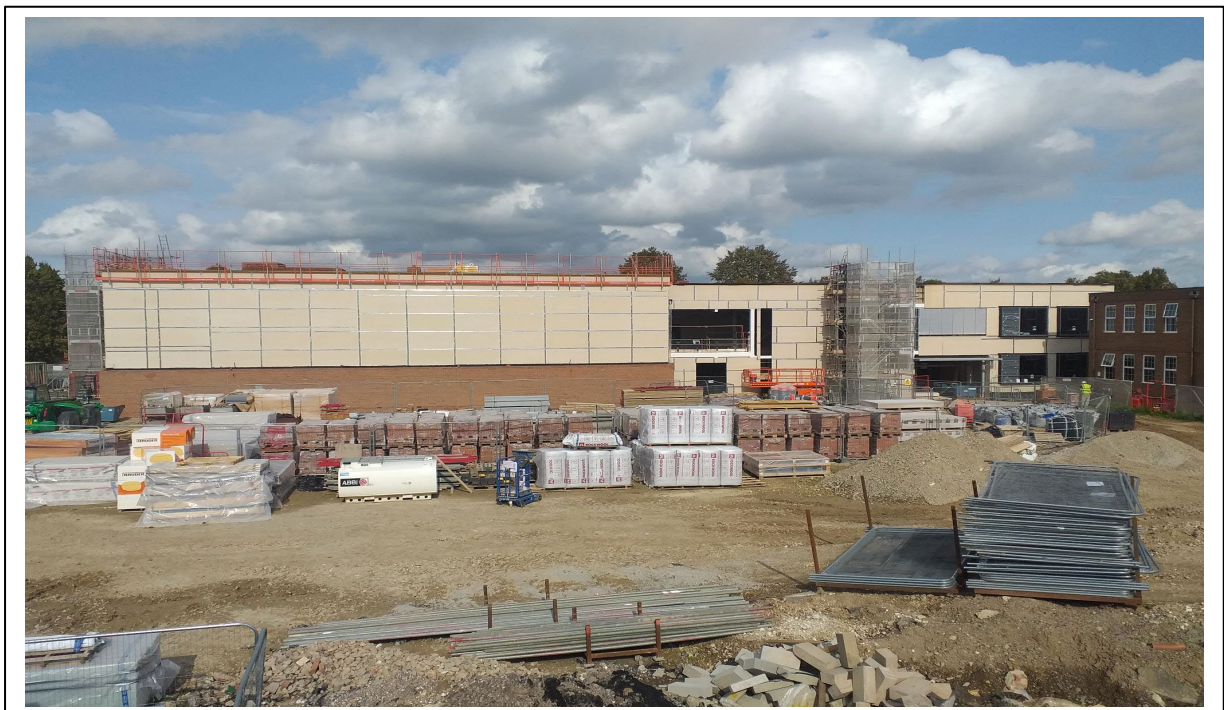
**Location:** Façade South elevation

**Description of Works:** Progress on the facade
